Manhole Inspection Summary

Manhole # S13YY_005MH

Location Address: **3105 SEQUOIA AVE**

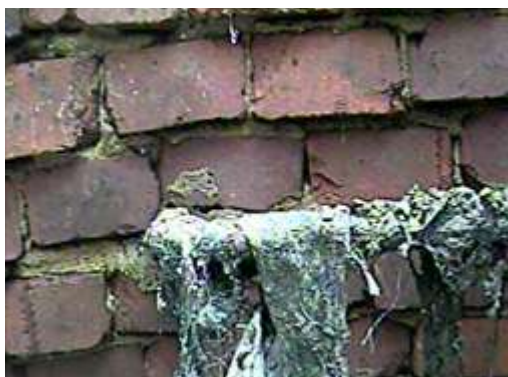
Defect 1

Surcharge ☒ **Evidence Of Surcharge** Depth: **2** (ft.) ☐ Active Surcharge Present

EVIDENCE OF SURCHARGE

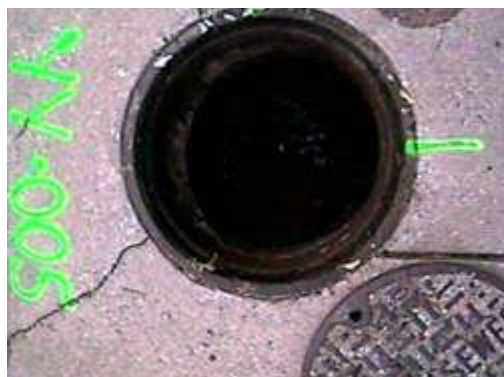
Defect 2

Frame Offset: **3** (in.) Condition: ☒ Sound ☐ Cracked ☐ Leaks

FRAME OFFSET

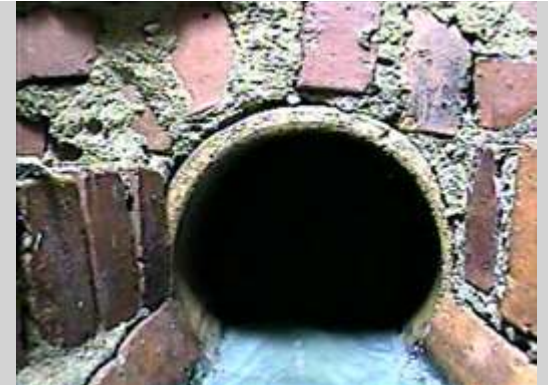
12 O'Clock Outflow

8 in. Circular Gravity Sewer
Pipe Out @ 12 O'Clock

Pipe Height: (in.) Direct
Pipe Material: **Clay** ☐ Pipe Lined
Invert Depth: **6.07** (ft.) Flow Characteristics: **Slow**
Deposits: ☒ None ☐ Mud ☐ Sludge ☐ Debris ☐ Grease
Silt Depth: (in.) Deposits Extent:
Infiltration: **None** Pipe Seal Cond: **Cracked**

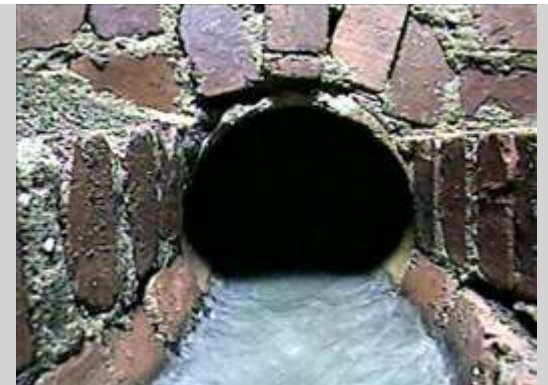
3 O'Clock Inflow

8 in. Circular Gravity Sewer
Pipe In @ 3 O'Clock

Pipe Height: (in.) Direct
Pipe Material: **Clay** ☐ Pipe Lined
Invert Depth: **6.05** (ft.) Flow Characteristics: **Slow**
Deposits: ☒ None ☐ Mud ☐ Sludge ☐ Debris ☐ Grease
Silt Depth: (in.) Deposits Extent:
Infiltration: **None** Pipe Seal Cond: **Sound**
